Re: Notice of Violation  
RCRA Compliance Evaluation Inspection  
EPA ID No: IN5 170 023 498

COMPLIANCE EVALUATION INSPECTION REPORT

**INSTALLATION NAME:** Crane Naval Surface Warfare Center

**DATE OF INSPECTION:** May 6-8, 2014

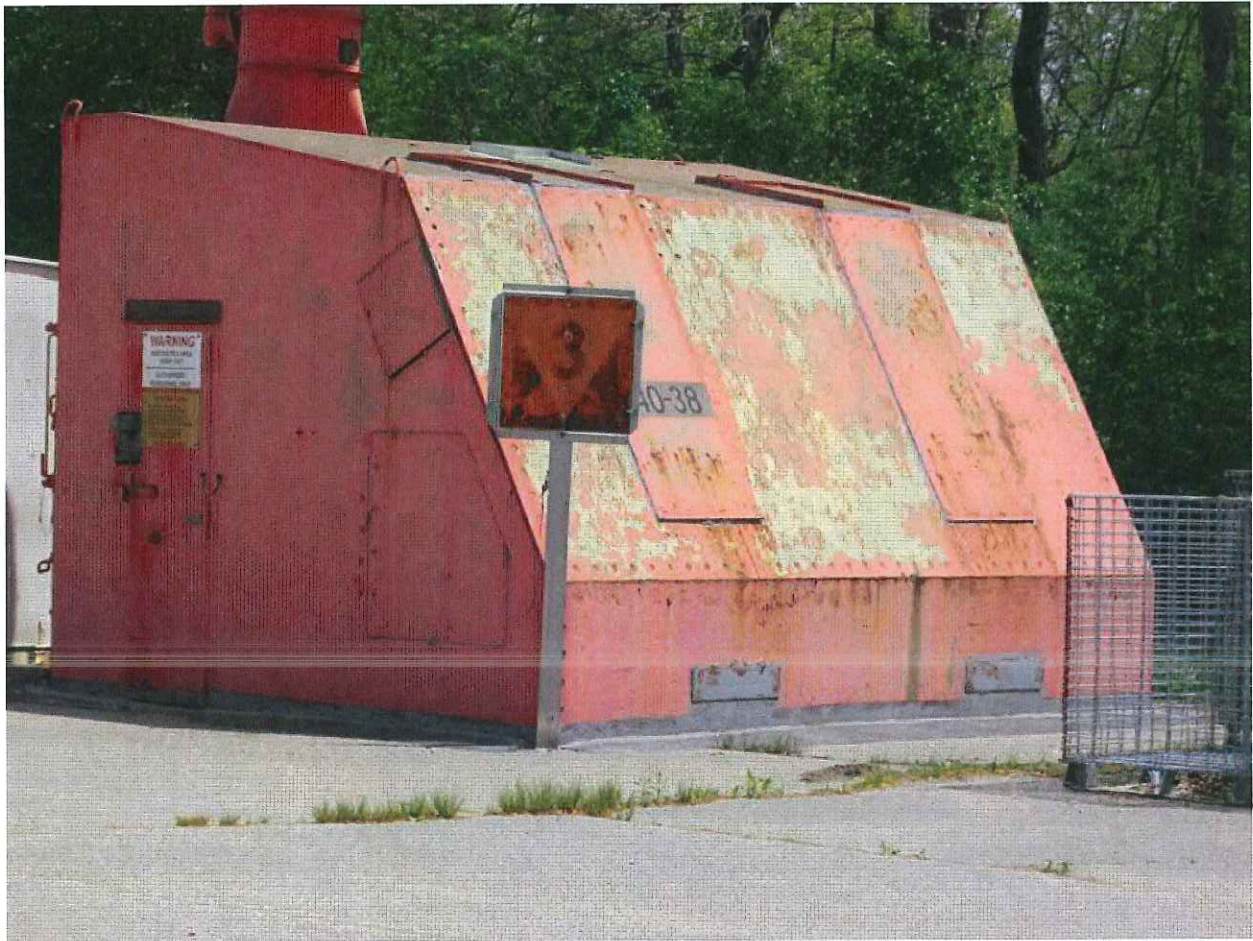
**PHOTOGRAPH #58**

- There was one closed/labeled 55-gallon drum of contaminated waste rags, one 55-gallon container of flare comp. and one 15-gallon container of assembled compounds, subassembly w/explosives in the explosive hazardous waste storage area (Photographs 58 and 59).
